Manhole Inspection Summary

Manhole # S43KK_023MH

Location Address: **1529 NORTH AVE (REAR)**

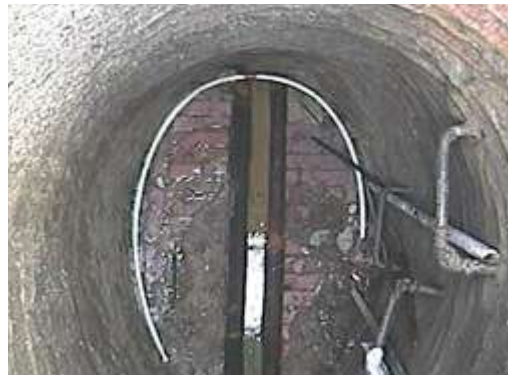
Defect 2

Steps Count: **4** Missing: **0** ☒ **Corroded**

STEPS CORRODED

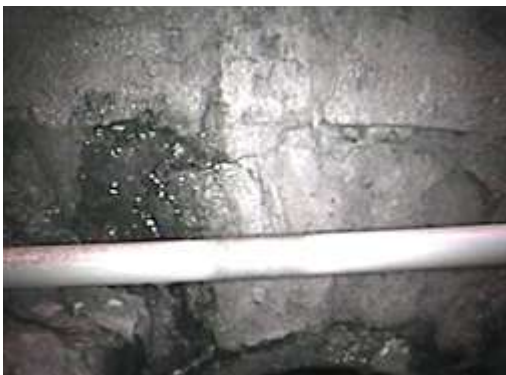
Defect 1

POSSIBLE INFILTRATION (WEEPER)

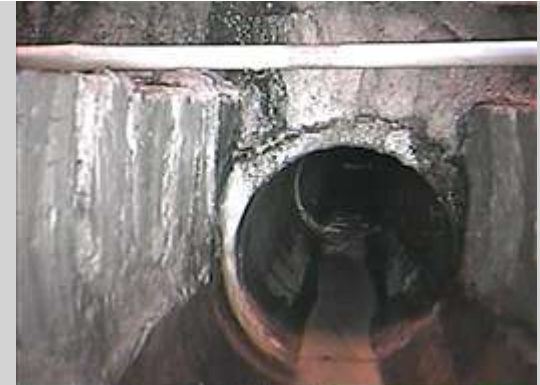
12 O'Clock Outflow

8 in. Circular Gravity Sewer
Pipe Out @ 12 O'Clock

Infiltration: **Weeper** Pipe Seal Cond: **Cracked**

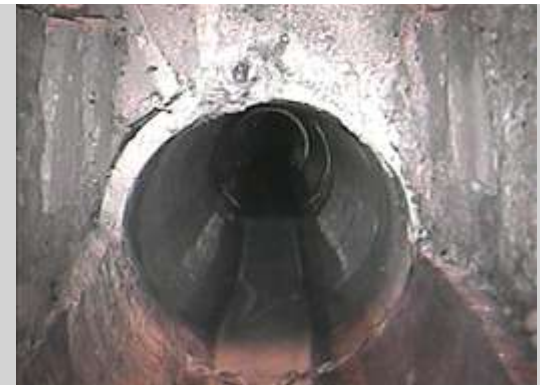
6 O'Clock Inflow

8 in. Circular Gravity Sewer
Pipe In @ 6 O'Clock

Infiltration: **None** Pipe Seal Cond: **Sound**
